BUILDING INSPECTION REPORT

Complies with Australian Standard AS 4349.1-2007

Inspection of Buildings Part 1: Pre-Purchase Inspections - Residential Buildings - Appendix "C"

South East Queensland

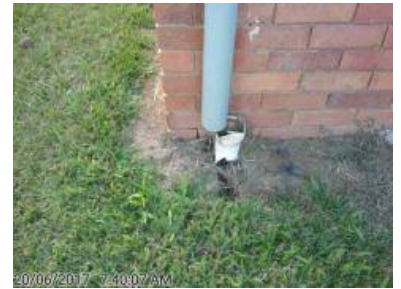
Downpipe(s) from roof gutter are broken/disconnected at ground level. Some maintenance required. Dampness is conducive to movement and settlement of the building foundations. Various areas.

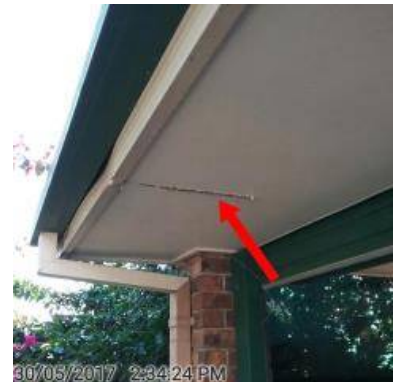
The overall condition of the eaves lining is fair. Damage noted at front of building, repair required.

The overall condition of the fascias/bargeboards is fair. Damage section, see photo above.

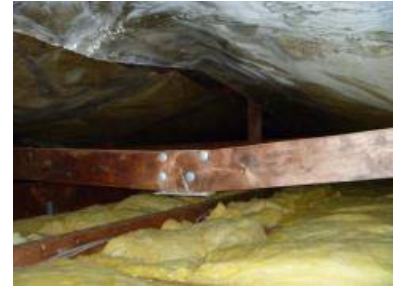
The truss and cut and pitched roof timbers appear to provide adequate support. Poor repairs noted above hallway. A licensed building contractor should be called to make a further evaluation for repairs where necessary.

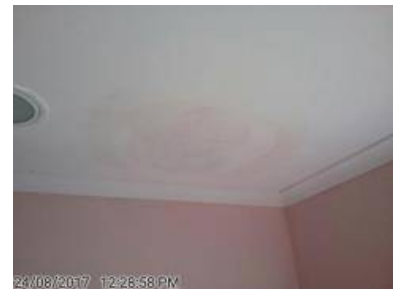
The condition of the ceilings is generally fair. Evidence of current water penetration through ceiling. See notes in roofing section. Repairs are required. Main bedroom.

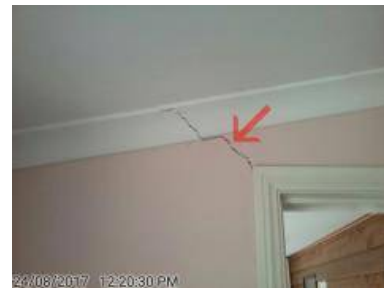
Bedroom two.

Moderate settlement cracks were noted. This is considered a serviceability defect. Some repairs are advised. Refer 4.7 Cracking of building elements note.

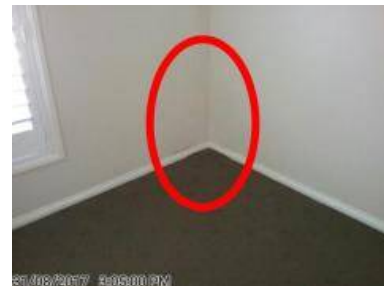
Termite damage noted to visible timbers. Refer Timber Pest Report. Main bedroom.

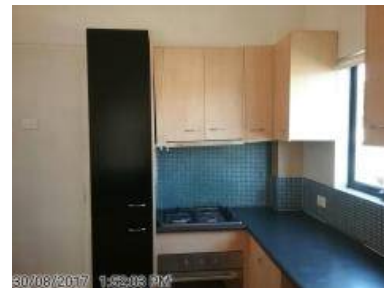
The condition of the fixtures is generally poor. Budgeting for replacement should be considered.

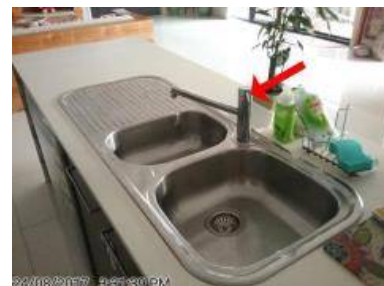
Tap leak from tap bodies was found, Repairs required.

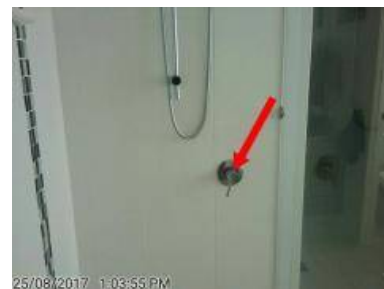
Shower and Bath appears to be in a serviceable condition. Some tap maintenance required. Minor leaking noted to the tap, it appears that water is leaking into frame/cavity of walls behind tap.. A separate special purpose report should be obtained from a licensed plumber to further investigate the extent of rectification works required, the most appropriate method of rectification and the probable costs of rectification.

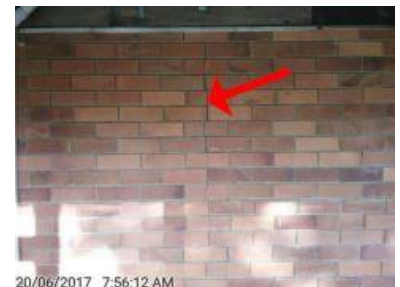
Right hand side elevation.

Serviceability cracks noted to areas of external walls indicates that settlement/movement to structure has occurred. The area(s) where cracking was noted is listed below. Refer 4.7 Cracking of building elements note.

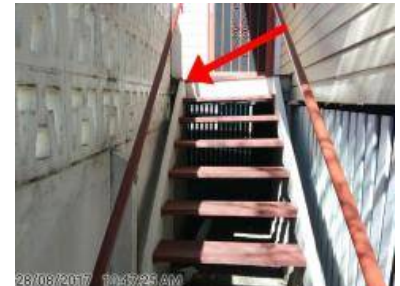
The overall condition of the stairs is poor. The stairs are constructed primarily from timber. Severe wood decay to sections of timbers, repairs are required. Further investigation is recommended. Recommend a builder or competent building maintenance person to further investigate the extent of rectification works required and the most appropriate method of rectification and the probable cost of rectification.

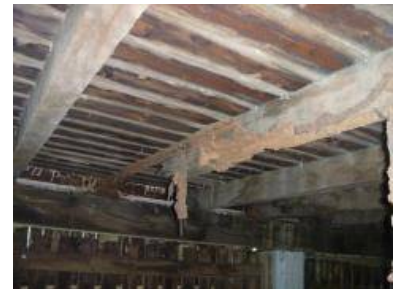
Below the following location or area: Bathroom.

Severe damage due to timber pest attack to visible accessible timbers. Refer a Timber Pest Report. Repairs will be required. We strongly recommend further investigation to the building. An investigation (by a competent person, example a licensed building contractor, etc) is recommended to determine the extent of damage found. The further inspection is strongly recommend of the areas that were not readily accessible on day of inspection.

Floor joist/s. Bearers.

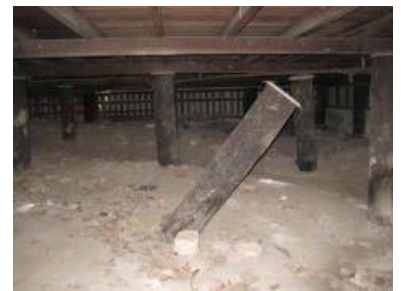
Some stumps have sunk and presently not supporting building, these stumps should be replaced. Recommend a suitable experienced restumping contractor to further investigate and give probable cost of replacement/rectification.

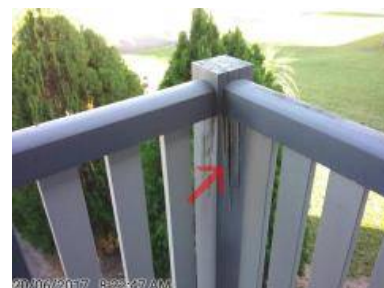
Construction & Condition: Constructed from timber. The general condition of this structure is poor. Repairs or maintenance is required.

Defects or Maintenance Items: Severe wood decay is present to the structure. Repairs or replacement of some timbers to the handrailing will be required. Recommend a builder or competent building maintenance person to further investigate the extent of rectification works required and the most appropriate method of rectification and the probable cost of rectification.

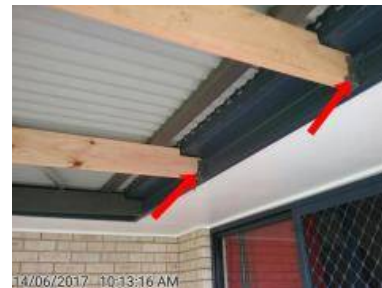
Position/Location: Front elevation.

Defects or Maintenance Items: Pergola rafters have been attached via metal joist hangers to metal fascia. This type of fixing and having roof sheeting in place does not comply with current Building Codes. Rectification recommended. Recommend client or clients solicitor make the necessary enquires with the local council as to the legality of the structure. Recommend a builder or competent building maintenance person to further investigate the extent of rectification works required and the most appropriate method of rectification and the probable cost of rectification.

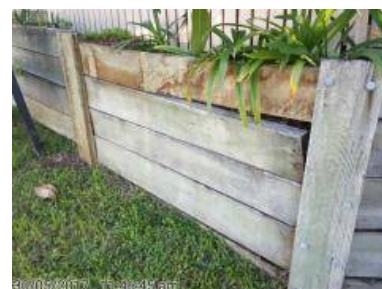
Location: Right hand side. Rear section.

Type & Condition: Severe wood decay damage was noted. Repairs/replacement of members will need to be carried out. An investigation (by a competent person, example a licensed building contractor or plumbing contractor, etc) is recommended to determine the extent of damage found. The further inspection is strongly recommend of the areas that were not readily accessible on day of inspection.

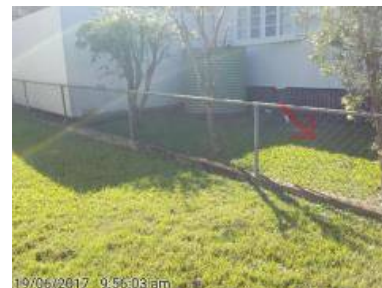
Surface water run off appears to be directed in the direction of the dwelling. All surface water should be diverted away from house footings/foundations. The retention of water from inadequate surface run off could have effect on the foundation material which in turn could affect the footings of the building. Recommend to install surface diversions/drainage to control the flow of surface water.
