VISUAL BUILDING INSPECTION REPORT

Complies with Australian Standard AS 4349.1-2007 Inspection of Buildings Part 1: Pre-Purchase Inspections - Residential Buildings - Appendix "C"

Inspection Date: 2012

Brisbane

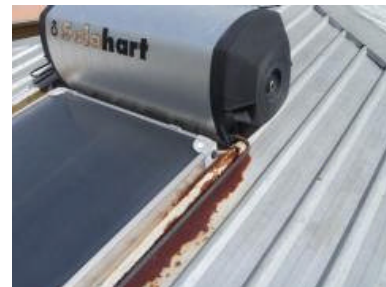
Roof Covering Condition Detail: The overall condition of the roof coverings is good. The metal roofing is rusting to sections and requires rust treatment to limit further deterioration. Some replacement or repairs to sheets should be budgeted for. Recommend to contact a roofing contractor for further advise.

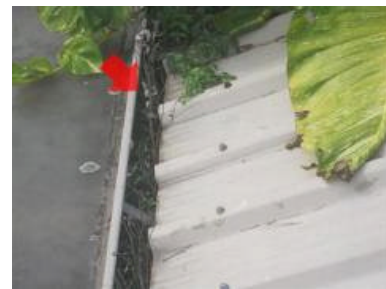
Condition: Gutters and downpipes appear to be in serviceable condition. Evidence of leaks to downpipes and gutters at corners and joins, maintenance required. Leaves and debris are present blocking up gutters. These should be cleared. Removal of debris will extend life of guttering and prevent water penetration to roof cavities.

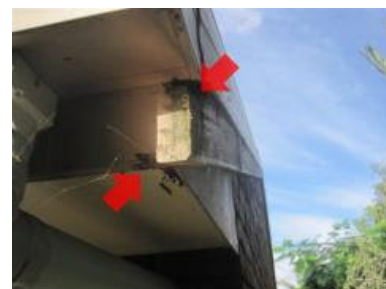
Eaves Condition: The overall condition of the eaves lining is fair. There are some minor defects noted, maintenance to these items/elements is recommended to prevent further deterioration. The paint work to the eaves is deteriorating and maintenance is required.

Fascias & Bargeboards Condition: The overall condition of the fascias/bargeboards is poor. Severe wet rot decay is present to timber fascias and barge boards. Some replacement is required.

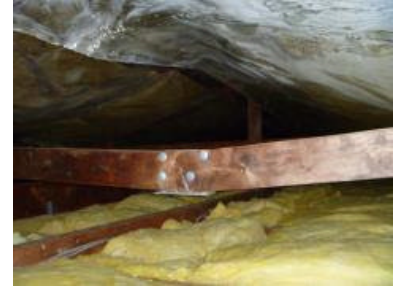
The truss and cut and pitched roof timbers appear to provide adequate support. Inadequate repairs to a collar tie. A licensed building contractor should be called to make a further evaluation for repairs as necessary.

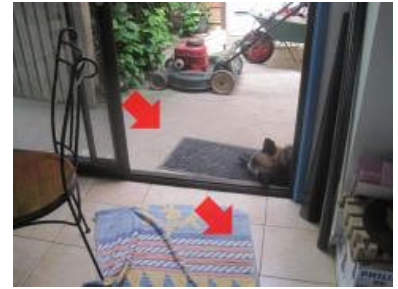
The condition of the floors is generally good. Some drummy tiles were noted to sections (mainly entry). Tiles can be affected by moisture, unsuitable substrate surfaces, differential movement of materials and/or tiler error or faulty adhesives. Advise regarding drummy tiles requires further investigation by a licensed and suitably experienced tiler. The internal floor level to Detached entertainment area is less than 75mm above the adjacent external finished level. This may result in stormwater entering the building.

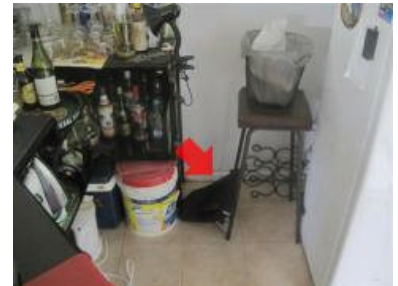
Wood decay damage to skirting board, repair/replacement required. Wood decay is present to the window frames. General wear and tear is noted.

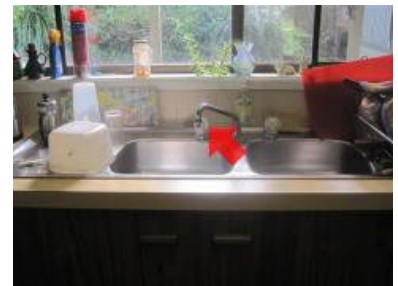
Tap leak from tap bodies was found, Repairs required.

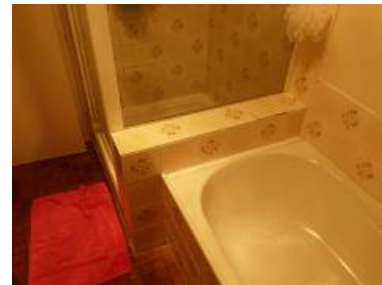
The condition of the tiles is generally good. All sealants to bathroom walls need maintenance due to deterioration/gaps appearing to prevent moisture penetration. Some cracked tiles were noted to walls in areas.

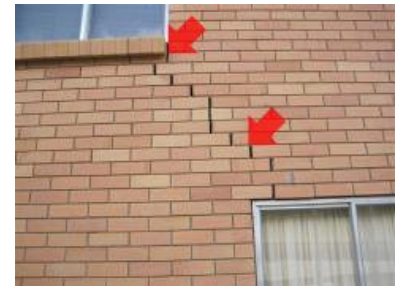
The condition of the walls is generally good. Cladding at rear of detached entertainment area is in contact with the ground. This can lead to undetected termite entry and wood decay. Recommend to clear all soils away from this area. Refer to Timber Pest Inspection Report. Separation and movement noted to areas of external walls near windows, this is a serviceability defect and indicates that settlement/movement to structure has occurred. This is possibly due to climatic conditions suffered by foundation soils, downpipe leaks, mature trees close to building or poor surface drainage. Reading this report in full provides information of conducive conditions to structural damage found on day of inspection. The area(s) where separation was noted is listed below.

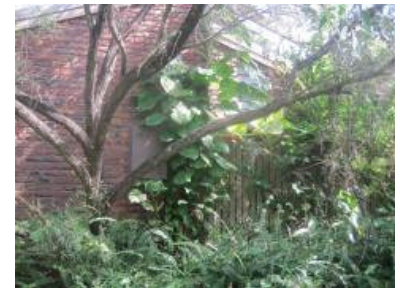
Garden beds and widespread foliage is built up against the external walls mainly to front of building and there is inadequate clearance between weep holes and ground levels. A minimum of 75mm clearance is required. Garden beds and foliage should be removed to prevent damp problems and concealed pest attack.

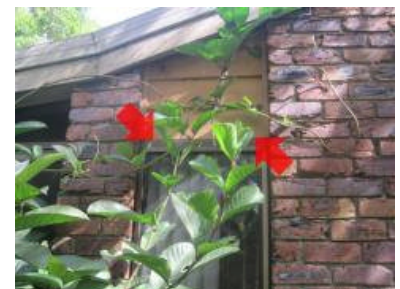
Window flashings are not present to top of windows and need to be fitted to ensure water does not penetrate through this area. Some general repairs and maintenance required to screens and frames.

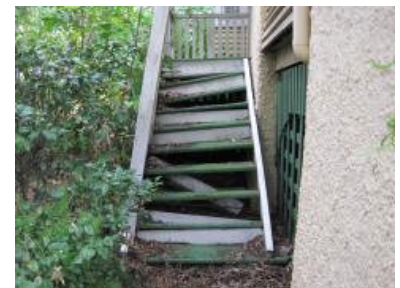
The overall condition of the stairs is poor. The stairs are constructed primarily from timber.

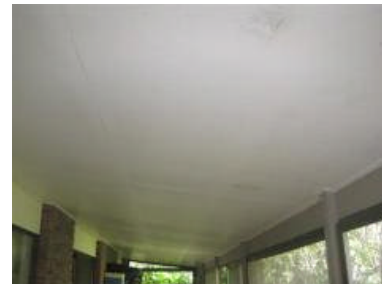
Mould was noted to the ceilings. The cause of this should be investigated and rectified.

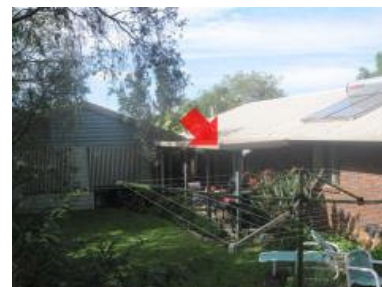
The timbers show signs of age and weathering. Moderate wood decay is present to the structure. Some repairs or maintenance will be required. Oregon timbers noted, recommend to replace these timbers with timber suitable for external use. A Building contractor should further investigate the cause and the extent of rectification works required and the most appropriate method of rectification and the probable cost of rectification.

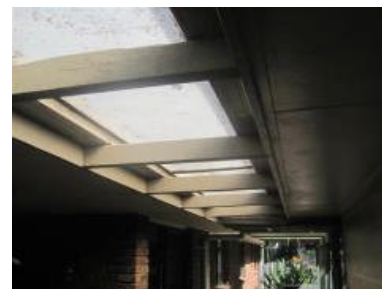
Moderate wood decay is present to the structure. Clear roof sheeting is not water proof and is leaking into areas below. Suggest to remove roofing and replace by constructing a roof above guttering over hanging main roof sections.

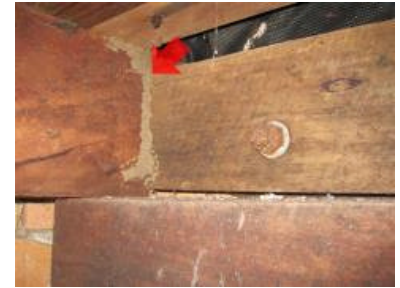
Bearers.

Below the following location or area: Bathroom.

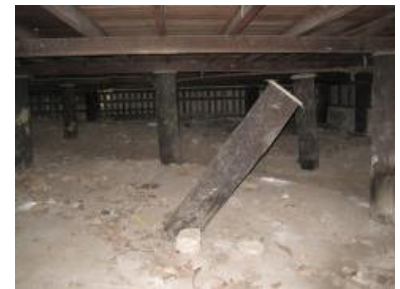
Some stumps have sunk and presently not supporting building, these stumps should be replaced. Recommend a suitable experienced restumping contractor to further investigate and give probable cost of replacement/rectification.

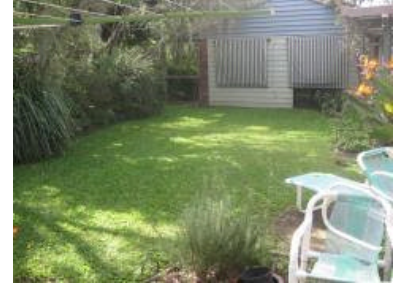
The drainage at the right hand side of the property out from pergola area appears inadequate. Drains should be installed at the right side to divert seepage and surface runoff water away from the house. The drains should be connected to the existing stormwater drainage system.
