## **VISUAL PEST INSPECTION REPORT**

Inspection Date: 2018

South East Queensland

# VISUAL TIMBER PEST INSPECTION REPORT

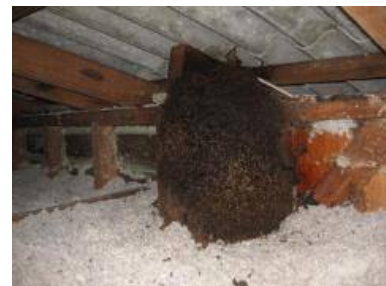
**Above the following location or area** Bathroom.

<b>Termite Activity</b>	Yes - Inspection revealed currently active termites within this area including but not necessarily limited to the following timbers and the areas listed below. Yes a Termite nest found.
<b>The termites are believed to be</b>	<i>Coptotermes</i> spp.

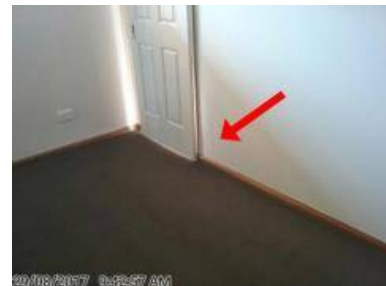
Main bedroom.

Yes - Inspection revealed currently inactive termite attack (damaged timbers and/or termite workings) within this area including but not necessarily limited to the following timbers and the areas listed below.

Wall sheeting/ linings, Skirting timbers.

Visible timber damage appears moderate however, this opinion is based on a visual inspection. A special purpose report can offer a more detailed description. Refer to the definitions section of this report.

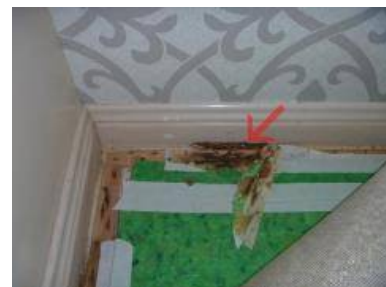
Dining room.

Yes - Wood decay damage was noted to the following timbers/areas.

Skirting timbers.

Visible timber damage appears minor however, this opinion is based on a visual inspection. A special purpose report can offer a more detailed description. Refer to the definitions section of this report.

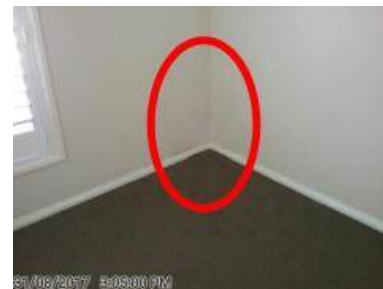
Bedroom three, front internal corner. Main bedroom wall backing onto ensuite shower.

High moisture levels were detected to some internal walls in or adjacent to the areas noted below. This can be an indicator of a free moisture source (water leak) or possible timber pest activity. In all cases where a high moisture level is encountered, we strongly recommend further investigations be carried out to determine the cause of this situation. Refer 9.0 The Presence of Excessive Moisture.

**Affected interior timbers and or areas** Wall sheeting/ linings.

Wall in main bedroom backing onto ensuite shower noted high than average reading or irregularities, this should be further investigated. See recommendations for further investigations in Summary in Detail.

Yes - High Moisture levels were detected by the moisture meter to some internal wall sections as indicated in the body of this report, this can be an indicator of a free moisture source (water leak) or possible timber pest activity. In all cases where a high moisture level is encountered, we strongly recommend further investigations be carried out to determine the cause of this situation.

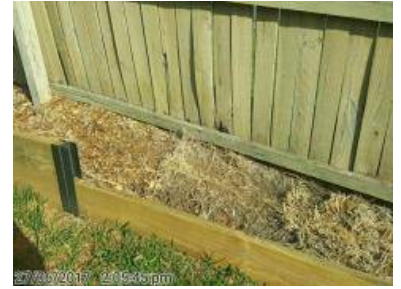
Left hand side:

Yes - Wood decay damage was noted to the following timbers/areas.

Visible timber damage appears severe however, this opinion is based on a visual inspection. We recommend a special purpose report of this area be carried out by a licenced and practicing Builder. Refer to the definitions section of this report.

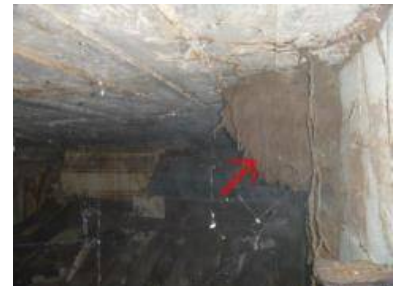
Below the following location or area  
Patio.

Yes - Inspection revealed currently active termites within this area including but not necessarily limited to the following timbers and the areas listed below.

The termites are believed to be *Schedorhinotermes* spp.
