VISUAL PEST INSPECTION REPORT

Brisbane

VISUAL TIMBER PEST INSPECTION REPORT

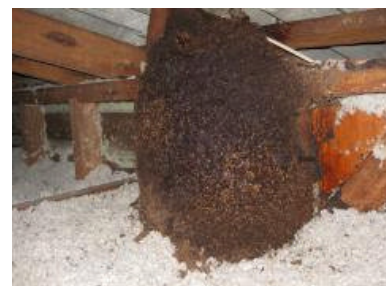
Active Subterranean Termites Found

Termite Activity Yes - Inspection revealed currently active termites within this area including but not necessarily limited to the following timbers and the areas listed below.

The termites are believed to be *Coptotermes* spp.

Affected roof timbers Ceiling joists. Roof beams. Visible wall frame timbers.
Above the following location or area Bathroom.

Severity Visible timber damage appears moderate to severe however, this opinion is based on a visual inspection. We recommend a special purpose report to this area be carried out by a licenced and practicing Builder. Refer to the definitions section of this report - Section 1.6 - Timber Damage.

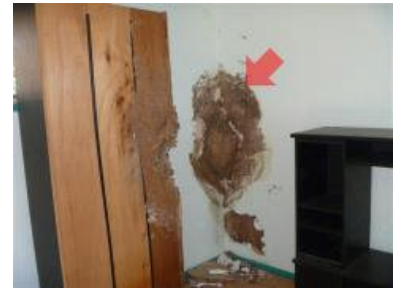
Active Subterranean Termites Found

Yes - Inspection revealed currently active termites within this area including but not necessarily limited to the following timbers and the areas listed below.

The termites are believed to be Affected interior timbers

Schedorhinotermes spp.
Wall frame timbers.

Family room. Behind Cupboard.

Visible timber damage appears severe however, this opinion is based on a visual inspection. We recommend a special purpose report of this area be carried out by a licenced and practicing Builder. Refer to the definitions section of this report - Section 1.6 - Timber Damage.

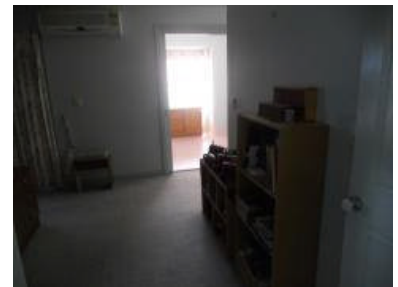
Main bedroom below A C unit.

High Moisture level detected

Higher than normal moisture levels were detected to some internal walls in or adjacent to the areas noted below. This can be an indicator of a free moisture source. In all cases where a high moisture level is encountered, we strongly recommend further investigations be carried out to determine the cause of this situation.

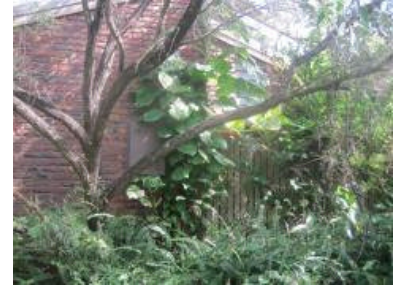
Inspection to sections of the exterior was restricted due to the growth of foliage. Foliage must be removed to enable a more complete report to be submitted.

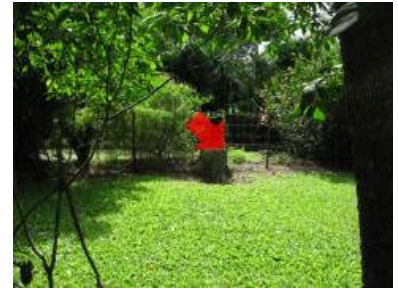
Active Subterranean Termites Found

Yes - Inspection revealed currently active termites within this area including but not necessarily limited to the following timbers and the areas listed below.

The termites are believed to be Affected external timbers

Microcerotermes spp.
Tree stump(s).

Right hand side of the property.
Visible timber damage appears moderate however, this opinion is based on a visual inspection. A special purpose report can offer a more detailed description. Refer to the definitions section of this report - Section 1.6 - Timber Damage.

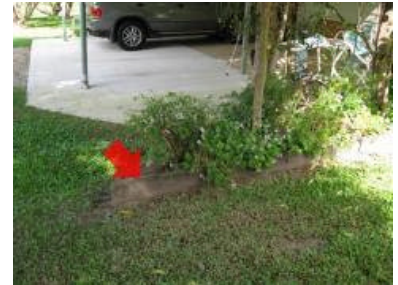
Yes - Inspection revealed currently inactive termite attack (damaged timbers and/or termite workings) within this area including but not necessarily limited to the following timbers and the areas listed below.

Tree stump(s). Timber retaining walls.
Loose timbers on ground or in ground.

Yard areas.
Visible timber damage appears moderate however, this opinion is based on a visual inspection. A special purpose report can offer a more detailed description. Refer to the definitions section of this report - Section 1.6 - Timber Damage.

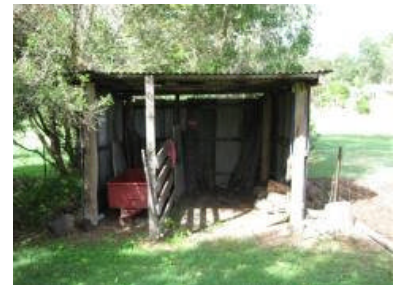
Yes - Borer damage was noted to the following timber(s)/area(s). Without destruction of the timbers it is not possible to determine whether activity exists or the extent of timber damage within.

Anobium borer damage was noted to posts It is not possible to chemically treat these timbers, replacement is recommended.

Visible timber damage appears minor to moderate however, this opinion is based on a visual inspection. A special purpose report can offer a more detailed description. Refer to the definitions section of this report - Section 1.6 - Timber Damage.

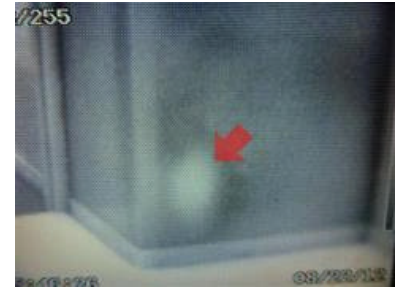
Abnormal Surface Temperature Found

Wall in main bedroom backing onto shower noted high than average reading or irregularities, this should be further investigated. See recommendations for further investigations in Summary in Detail.
