BUILDING INSPECTION REPORT

Complies with Australian Standard AS 4349.1-2007
Inspection of Buildings Part 1: Pre-Purchase Inspections - Residential Buildings - Appendix "C"

South East Queensland

VISUAL BUILDING INSPECTION REPORT

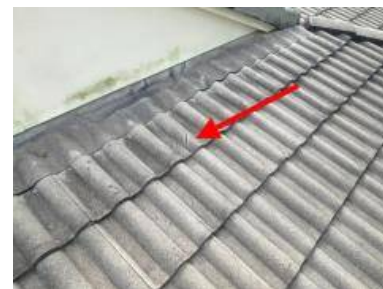
Roof Style: The roof is of pitched construction.
Roof Covering Condition in Detail: The overall condition of the roof coverings is generally good. Some defects noted. This is deemed typical in a building of this age. Some maintenance/repairs is required. The mortar to the ridge and hip capping has some general deterioration due to age and weathering. Recommend re pointing to prevent further deterioration and possible water penetration. A small number of cracked roof tiles were noted and should be replaced to prevent water ingress. Front elevation. Right hand side elevation. Left hand side elevation. Suggest roof surface be cleaned due to mould build up and staining noted.

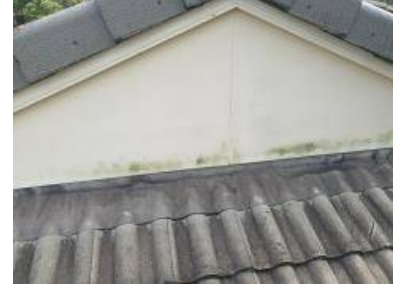
The external gable timbers show signs of age and weathering. Repairs and maintenance required, recommend sealants and painting.

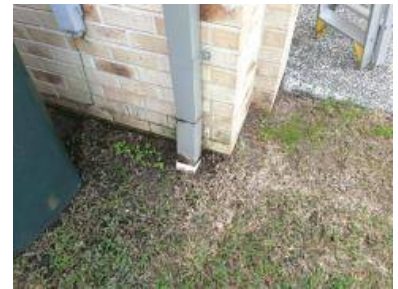
Down Pipe(s), Rusting. These should be repaired or replaced where necessary. Left hand side elevation. Evidence of leaks to downpipes and gutters at corners and joins, some maintenance required to prevent water damage to surrounding areas. Various sections of all elevations.

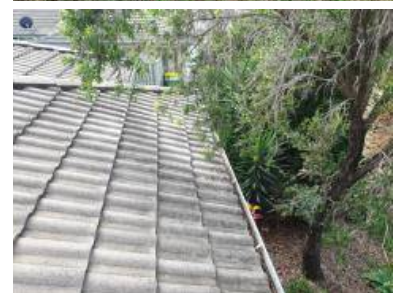
Leaves and debris are present in gutters. These should be cleared. Removal of debris will extend life of guttering and prevent water penetration to roof cavities. Various sections of all elevations.

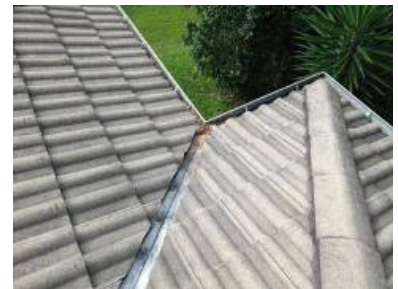
Leaves and debris to valley area. These should be cleared as water may penetrate below/ in this area.

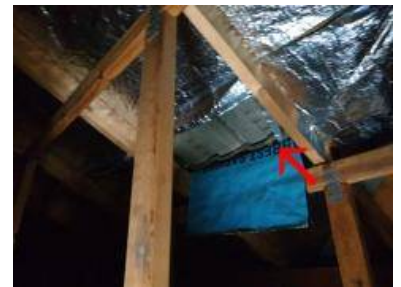
Sarking is present to roof cavity. Sarking is torn or has holes in some areas. This may affect the waterproofing ability of the sarking.

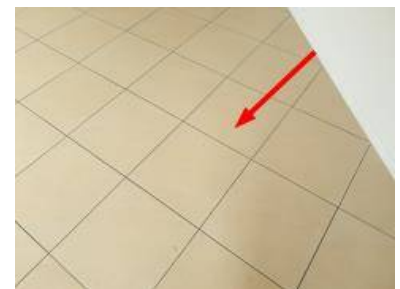
Floors are concealed by floor coverings to various areas. The condition of the floors is generally good. Chipped floor tiles are present. Family room.

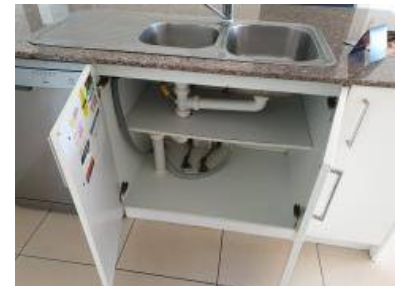
Kitchen Fixtures: The condition of the fixtures is good. Some areas have swelled and deteriorated due to moisture affecting the materials used in this situation/area. General wear to cabinets due to age.

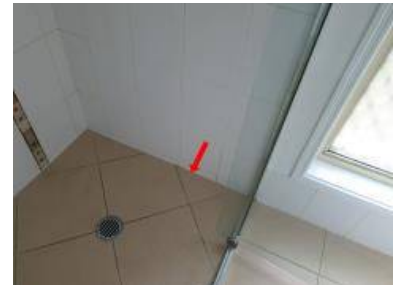
Shower appears to be in a serviceable condition. Some cracked tiles were noted to shower recess, recommend to seal or replace to prevent moisture penetration in this area.

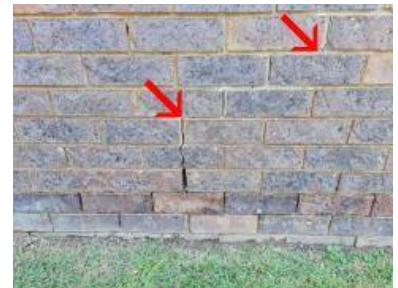
Position/Location: Rear elevation.

Cracking of Building Elements Appearance cracking is noted to areas of external walls indicates that settlement/movement to structure has occurred. The area(s) where cracking was noted is listed below. Refer 4.7 Cracking of building elements note.

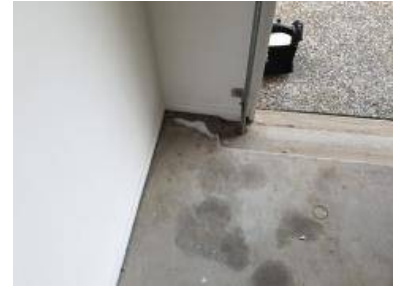
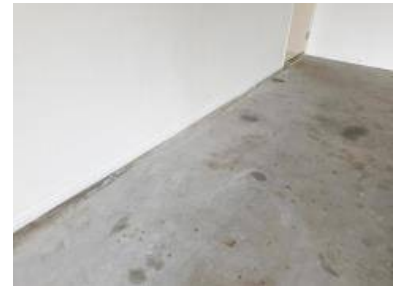
Where floor and wall join/ meet, salt/ damp staining to concrete was found to sections. The moisture meter did not detect high moisture levels at walls. The salt/ damp staining suggests some moisture in ingress to concrete maybe present. If excessive moisture enters wall frame this may cause wood decay to timbers. Recommend a builder or competent person to further investigate.

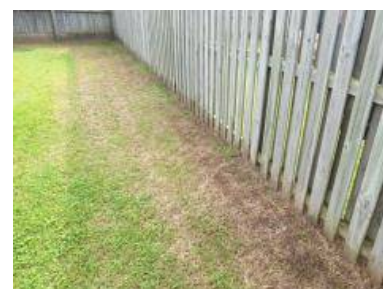
The fences are generally in fair condition. Minor wood decay was noted. Repair when necessary. Ground levels have built up against the base of fences in some areas. This build up can cause wood decay and/or conceal current timber pest attack and significantly increases the risk of future attack. Soil etc, should not be built up against fencing timbers and we recommend modifications be made.

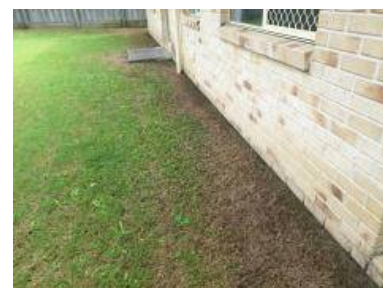
Evidence that stormwater may pond or not drain away adequately to left hand side of building.. Recommend a suitably licensed and practicing Plumber to further investigate the most appropriate method of rectification and probable costs of rectification works.

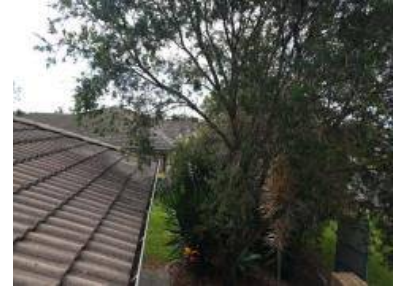
Yard and gardens appears to be well maintained. Mature trees located in close proximity to the building. Having trees close to the building can lead to problems such as leaves blocking gutters and downpipes, tree branches falling onto house, and are conducive to undermining/movement of the building foundations. Recommend engaging a suitably qualified and experienced arborist (tree specialist) or tree lopping contractor to advise on the best course of action and associated costs.
