## **TIMBER PEST INSPECTION REPORT**

South East Queensland

# VISUAL TIMBER PEST INSPECTION REPORT

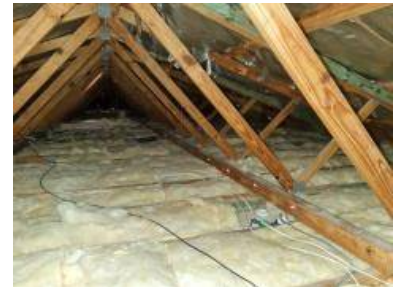
<b>Restrictions:</b>	Inspection over the eaves was restricted due to the low pitch and construction allowing only a limited visual inspection.
----------------------	---

<b>Restrictions:</b>	Partial Insulation is present in the roof cavity. This restricted inspection to some roofing timbers. Removal of insulation is not within the scope of a standard visual inspection report. Sarking membrane covered roof battens restricting inspection.
----------------------	---

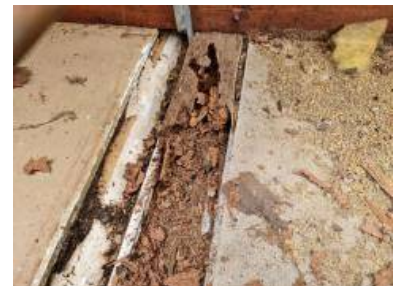
**Above the following location or area** Bedroom four. Lounge room. Hallway.

<b>Inactive workings caused by termites</b>	Yes - Inspection revealed currently inactive termite attack (damaged timbers and/or termite workings) within this area including but not necessarily limited to the following timbers and the areas listed below.
<b>Affected roof timbers</b>	Top wall plate timbers.

**Severity** Visible timber damage appears severe however, this opinion is based on a visual inspection. We recommend a special purpose report of this area be carried out by a licenced and practicing Builder. Refer to the definitions section of this report.

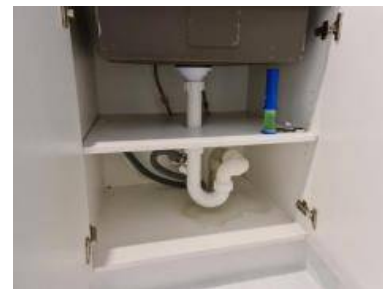
**Location/area** Laundry.

**Details** Water staining is present, suggests previous leak, Monitor for any change as moist conditions are conducive to timber pest attack. Refer 9.0 The Presence of Excessive Moisture. Water damage is present, this is conducive to excessive moisture. In all cases where the presence of moisture is encountered, we strongly recommend further investigations be carried out to determine the cause of this situation. Refer 9.0 The Presence of Excessive Moisture.

**Affected areas** Laundry cupboard timbers.

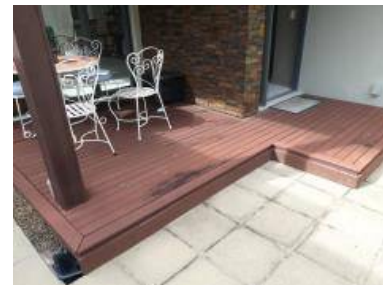
There is insufficient crawl space below the rear decking timbers due to the method of construction. See Section - Reasonable Access.

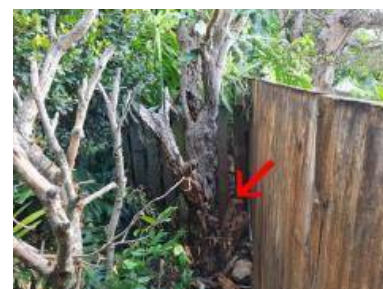
Yes - Inspection revealed currently active termites within this area including but not necessarily limited to the following timbers and the areas listed below.

*Microcerotermes* spp.  
Tree stump(s).

Visible timber damage appears minor however, this opinion is based on a visual inspection. A special purpose report can offer a more detailed description. Refer to the definitions section of this report.

Timbers such as these are attractive to subterranean termite attack and should be removed. Tree stumps.

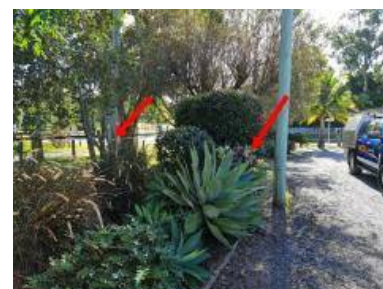
Tree(s).

Rear section of the property. Front section of the property.

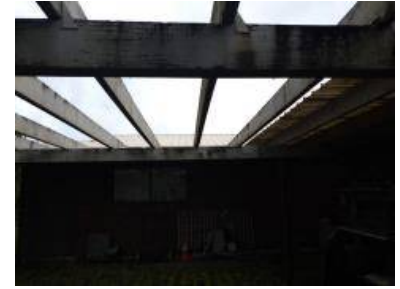
Rear section of the property.

Yes - Wood decay damage was noted to the following timbers/areas.

Patio timbers.

Visible timber damage appears minor however, this opinion is based on a visual inspection. A special purpose report can offer a more detailed description. Refer to the definitions section of this report.

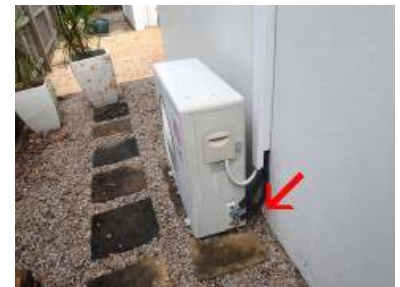
The potential presence of moisture in the form of, Air-conditioning unit(s) drain discharges moisture adjacent to the external walls. We recommend repair, or modification so that water is discharged over or into a drain, not causing damp conditions adjacent to building. These item(s) should be rectified as moist soil conditions are conducive to timber pest attack. Refer 9.0 The Presence of Excessive Moisture.

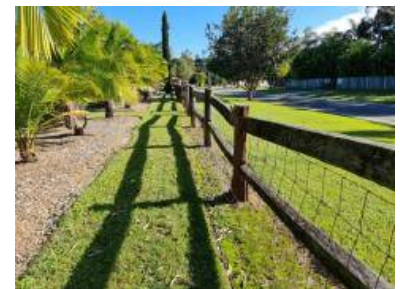
Front fence:

Yes - Inspection revealed currently active termites within this area including but not necessarily limited to the following timbers and the areas listed below.

*Microcerotermes* spp.

Visible timber damage appears minor to moderate however, this opinion is based on a visual inspection. A special purpose report can offer a more detailed description. Refer to the definitions section of this report.

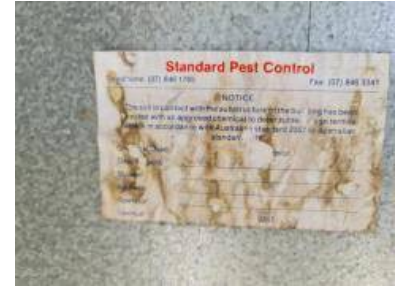
A notice indicates that the property has been treated during construction in respect to protection against subterranean termite attack. We recommend the client attempt to verify this information and obtain copies of all relevant documentation.

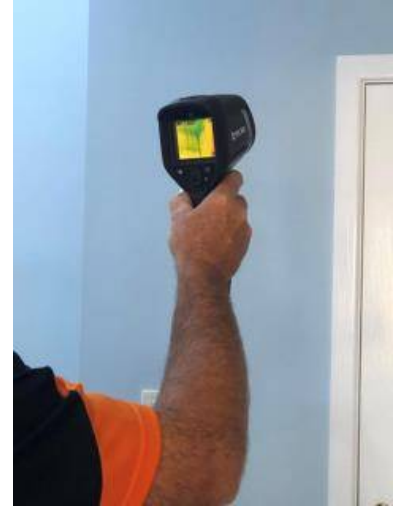
Thermal imaging/ scanning found no abnormalities or irregularities to surface temperature of visible areas at this time of inspection.
