BUILDING INSPECTION REPORT

Complies with Australian Standard AS 4349.1-2007

Inspection of Buildings Part 1: Pre-Purchase Inspections - Residential Buildings - Appendix "C"

South East Queensland

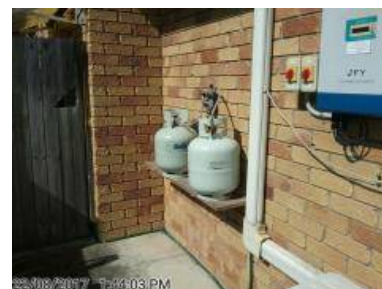
Water Meter: A Water meter is present.
Gas: Recommend gas bottles be adequately secured to the wall as a safety precaution. Electrical Safety Switch: A safety switch was found to be installed. Note: only a licensed electrician can verify if safety switch is connected to appropriate circuits. Air-conditioning is installed in the premises but has not been inspected. Smoke Alarms: Smoke detectors are fitted. From 1st January 2017, New Smoke Alarm Legislation has been put into place. From 1st January 2022, Smoke detectors must be photoelectric and interconnected with all other smoke detectors in the dwelling. The Inspector has not checked the type or quality of the alarm/s, the battery condition or if they are hardwired to the 240 volt power supply. It is essential to check the smoke alarms when you take

possession of the property. It is advisable to contact an electrical contractor in regard to smoke alarm installation. For more information about smoke alarms go to the web site
