BUILDING INSPECTION REPORT

Complies with Australian Standard AS 4349.1-2007
Inspection of Buildings Part 1: Pre-Purchase Inspections - Residential Buildings - Appendix "C"

South East Queensland

VISUAL BUILDING INSPECTION REPORT

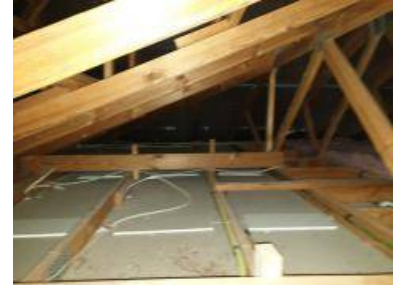
Inspection over the eaves was restricted due to the low pitch and construction allowing only a limited visual inspection. Insulation is present in the roof cavity. This restricted inspection to some of the buildings framework. Removal of insulation is not within the scope of a standard visual inspection report. Sarking membrane covered roof battens restricting inspection.

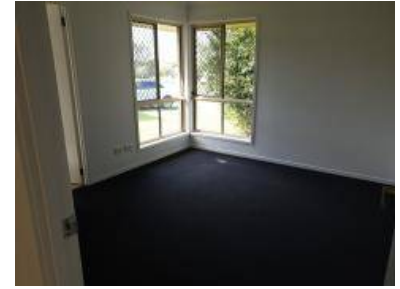
Floor coverings were present and restricted inspection to the upperside of floor structure.

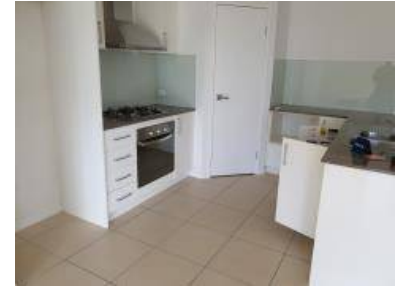
Kitchen:

General condition of area: This area is in good condition.

Kitchen Fixtures: The condition of the fixtures is good. Some areas have swelled and deteriorated due to moisture affecting the materials used in this situation/area. General wear to cabinets due to age.

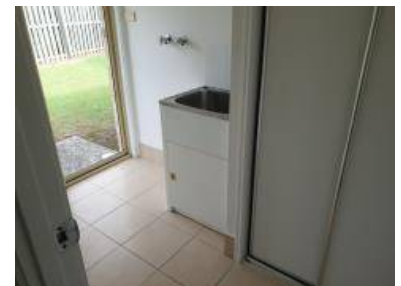
Laundry:

General condition of area: This area is in good condition.

Cabinets, Tubs & Taps: The tub and taps appear serviceable.

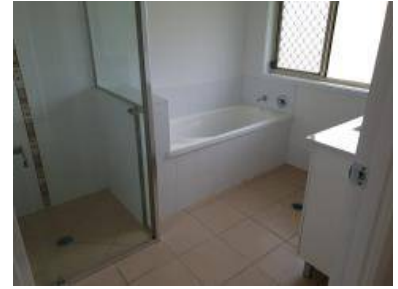
Bathroom:

This area is in good condition.

Shower and Bath appears to be in a serviceable condition.

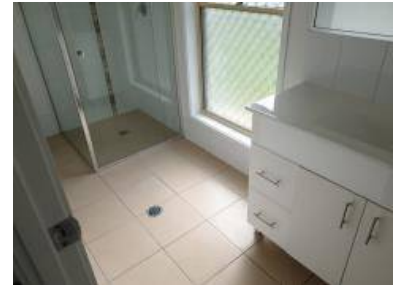
This area is in good condition.

Shower appears to be in a serviceable condition. Some cracked tiles were noted to shower recess, recommend to seal or replace to prevent moisture penetration in this area.

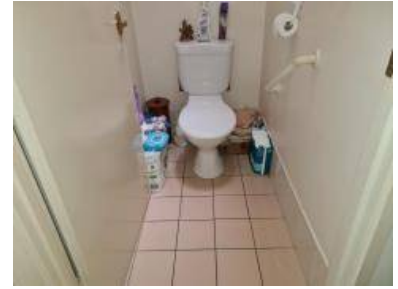
The toilet is in working order. The toilet is a dual flush type.

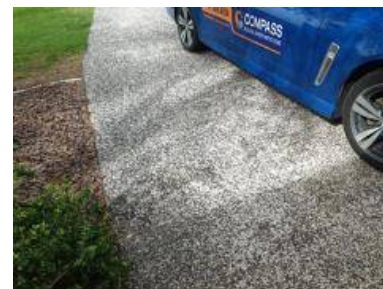
The concrete driveway stands in good condition.

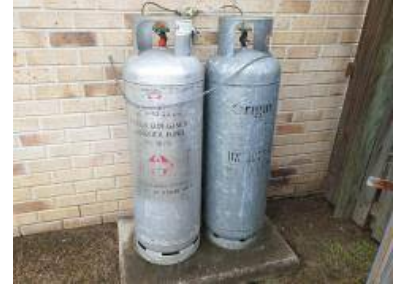
Gas is connected to the premises but has not been inspected. Gas is supplied to Cook Top. Hot Water System.

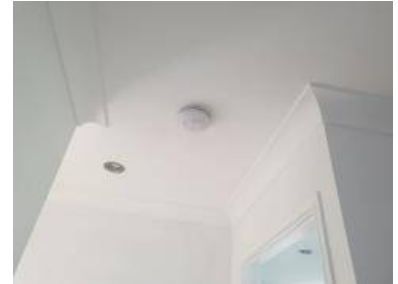
Smoke detectors are fitted. The Inspector has not checked the type or quality of the alarm/s, the battery condition or if they are hardwired to the 240 volt power supply. It is essential to check the smoke alarms when you take possession of the property. It is advisable to contact an electrical contractor in regard to smoke alarm installation. For more information about smoke alarms go to the web site

www.qfes.qld.gov.au/community-safety/smokealarms . Dwellings being sold , leased or and existing lease is renewed new smoke alarm requirements are affective from 1 January 2022. It is recommended that an electrician be consulted to check on positioning and installation of the smoke alarm(s) to whether the smoke alarm(s) meet the requirements of the legislation, homeowners should contact the Queensland Fire & Rescue Service Regional Manager Community Safety for advice.

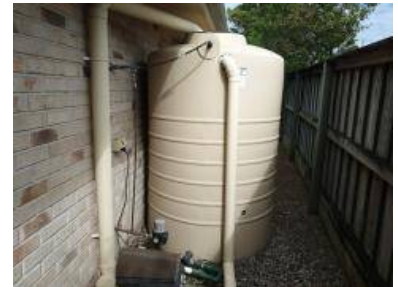
A water tank is present. Electric Pump is present, but has not been inspected.

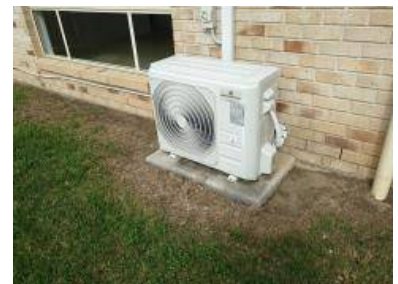
Air-conditioning is installed in the premises but has not been inspected.

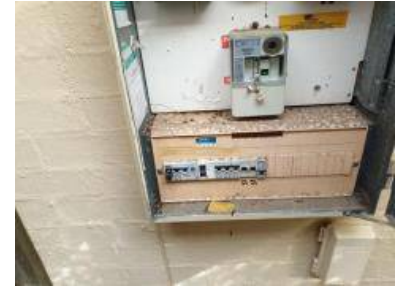
Safety switches were found to be installed. Note: only a licensed electrician can verify if safety switch is connected to appropriate circuits.

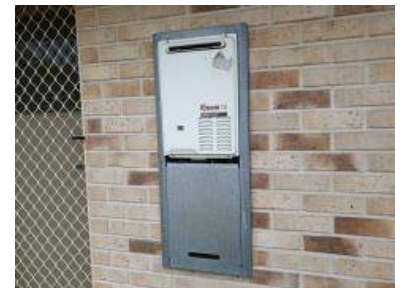
Gas hot water system: Instantaneous:
Located externally: The hot water system appears to be in working condition. No specific tests other than running the hot water from a tap was carried out. No determination has been made as to the suitability or adequacy of the hot water system in relation to capacity or otherwise.
